Elevation and frequency of occurrence of floods in Squaw Creek basin in Ames, Iowa

ELEVATION AND FREQUENCY OF OCCURRENCE
OF FLOODS IN SQUAW CREEK BASIN
IN AMES, IOWA

A Thesis Submitted to the
Graduate Faculty in Partial Fulfillment of
The Requirements for the Degree of
MASTER OF SCIENCE

Major Subject: Sanitary Engineering (Water Resources)

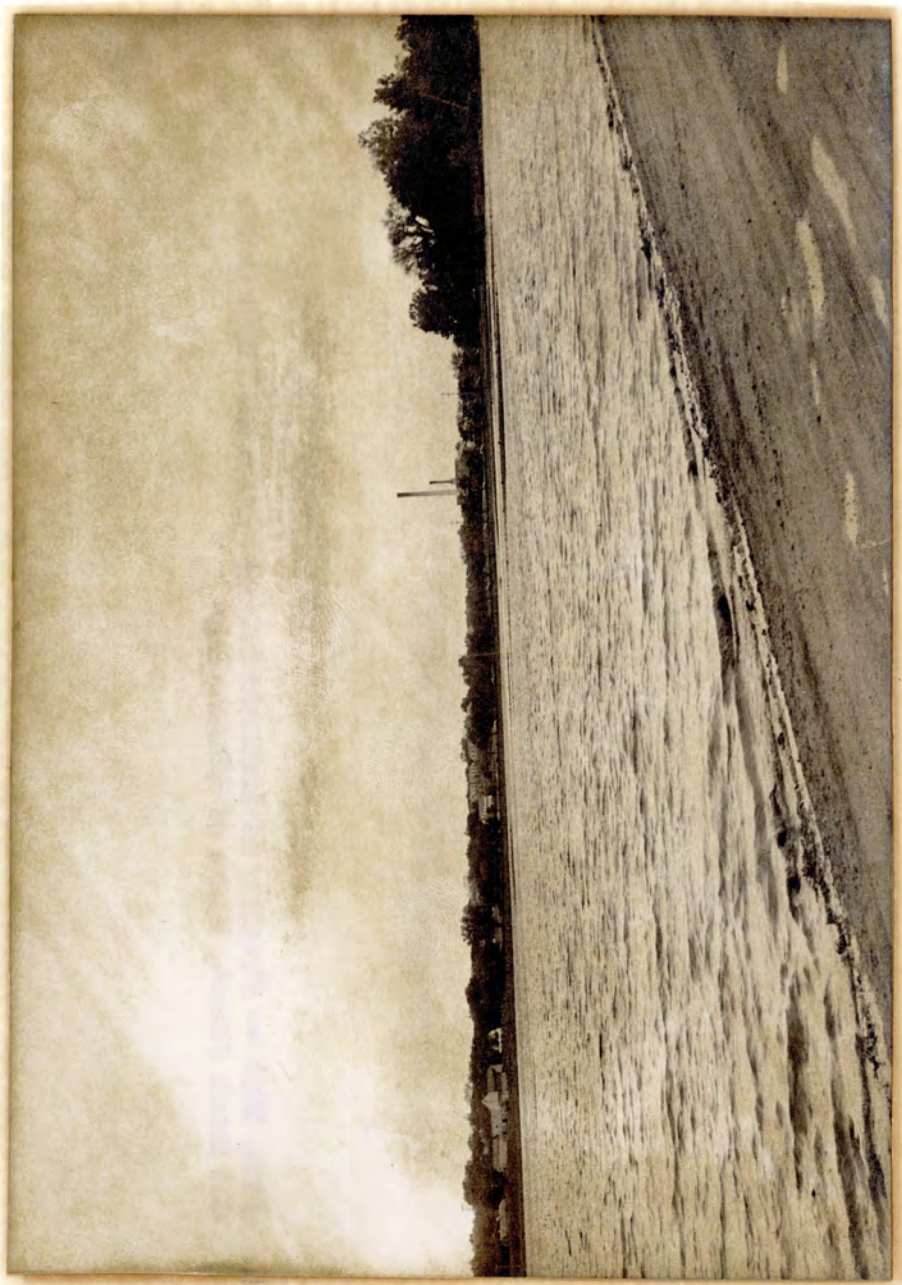
Figure 2. June, 1954 -- flooding of lowlands between South Riverside Drive and Beech Street, South of Lincoln Way

Views of some of these floods taken from various locations along Squaw Creek are shown in Figures 2, 3, 4, 5, 6, and 7. These photographs show that although extensive areas have been flooded in the past, the flooding has generally been relatively shallow.

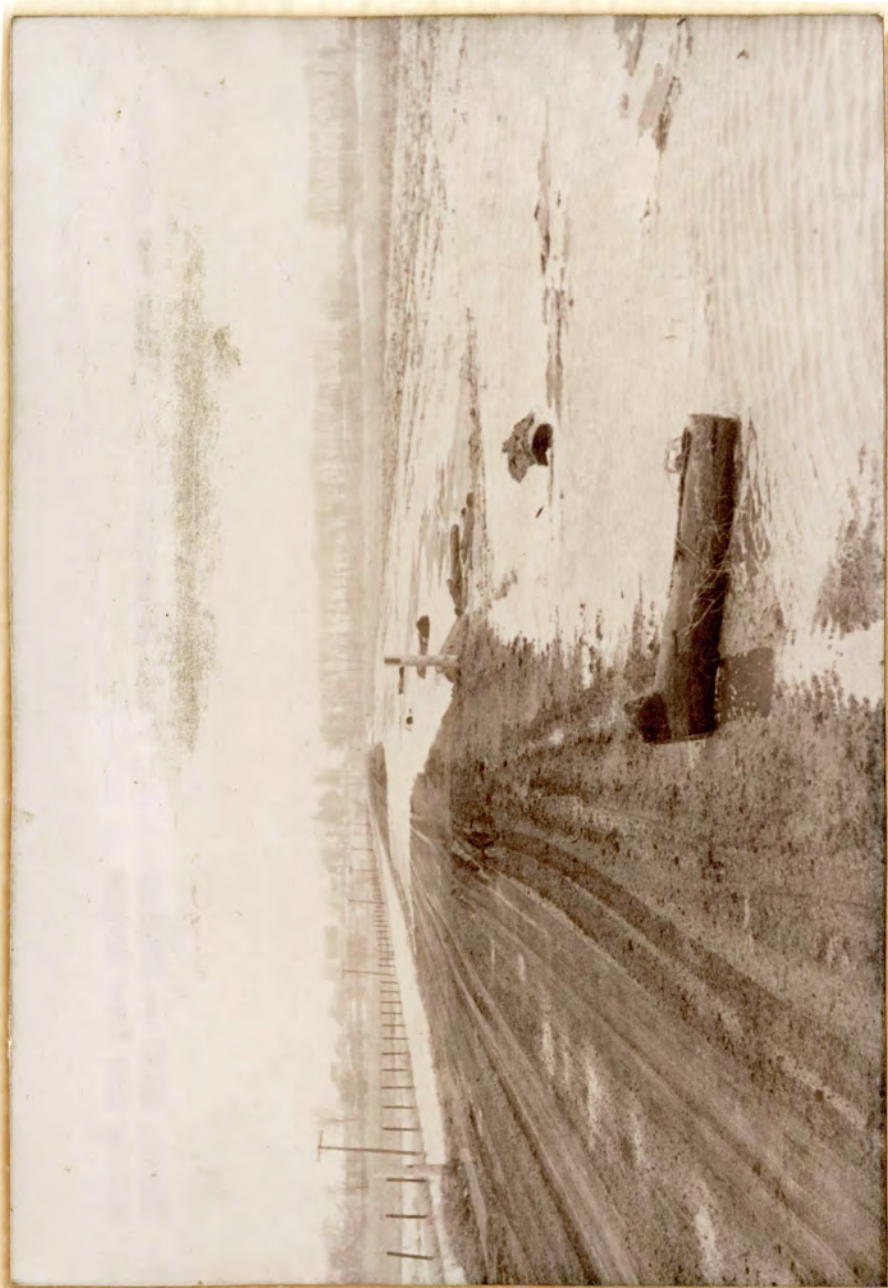
Figure 3. March, 1960 --- Flooding along South Riverside Drive (water was approximately one foot deeper at crest)

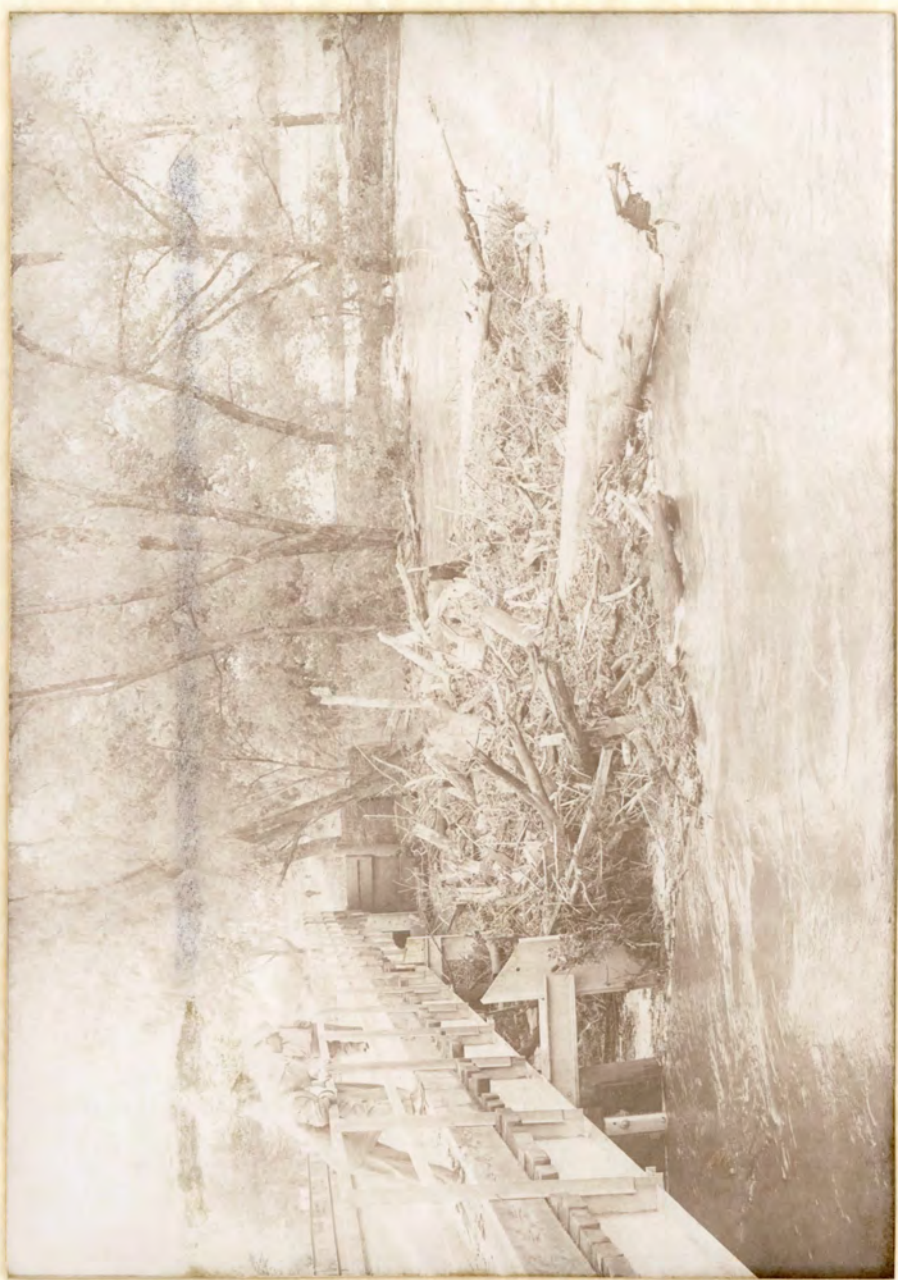
Figure 4. June, 1954 - debris accumulation at South Riverside Drive bridge

Allowances were made in backwater calculations for a slight accumulation of debris on bridge piers. It is possible for large quantities of debris to accumulate on the piers which would cause backwater and possibly flooding in excess of normal. However, the probability of this occurrence cannot be estimated. Design engineers using this data should make allowance for this occurrence by adding freeboard above that indicated by the flood profile curves.

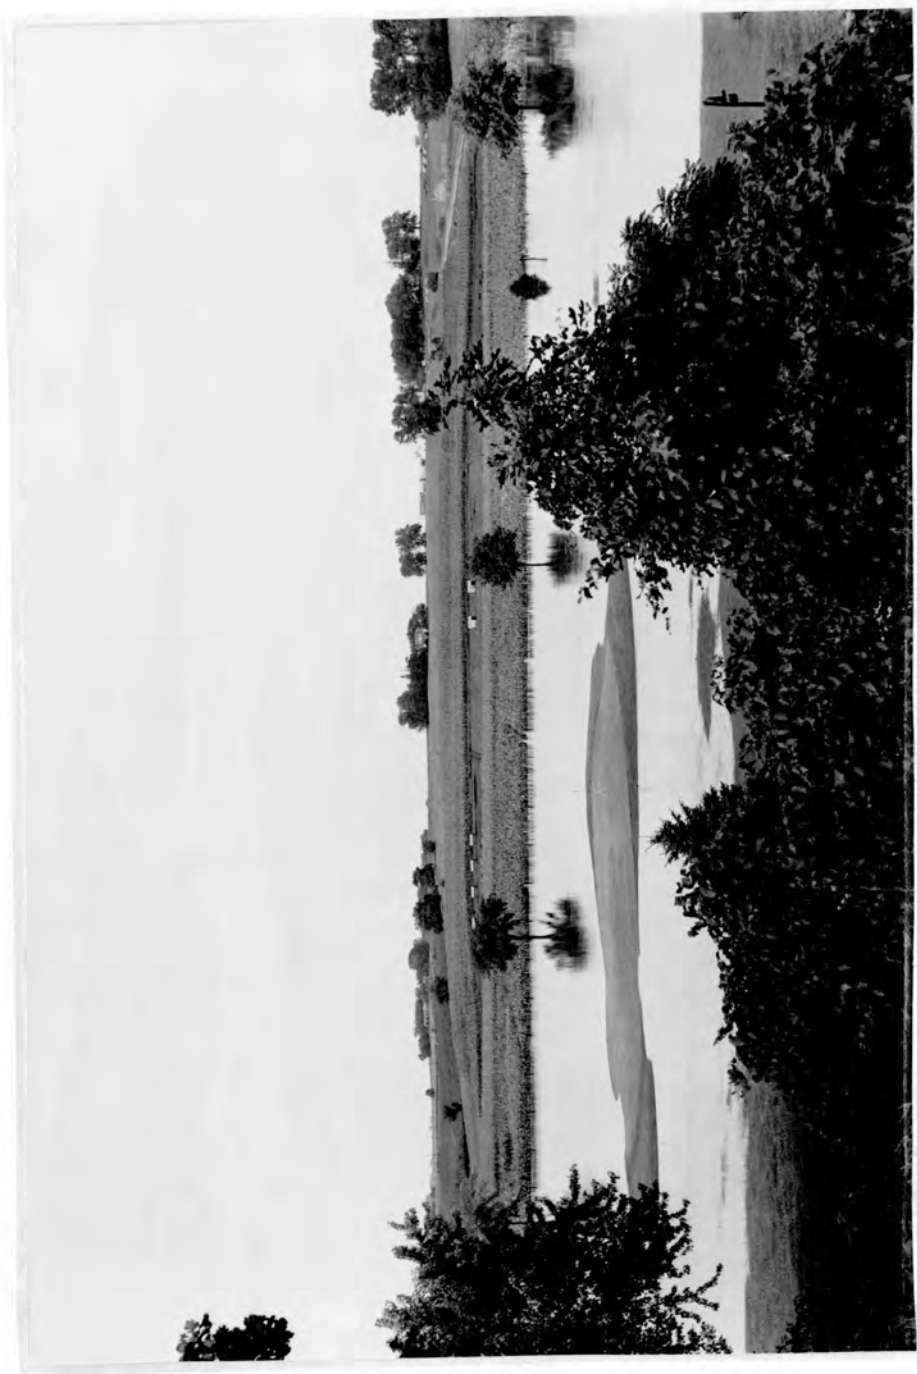
Figure 6. August, 1954 --- flooding of the University Golf Course
(The area is being considered as the new location of the University Golf
Course Club House.)

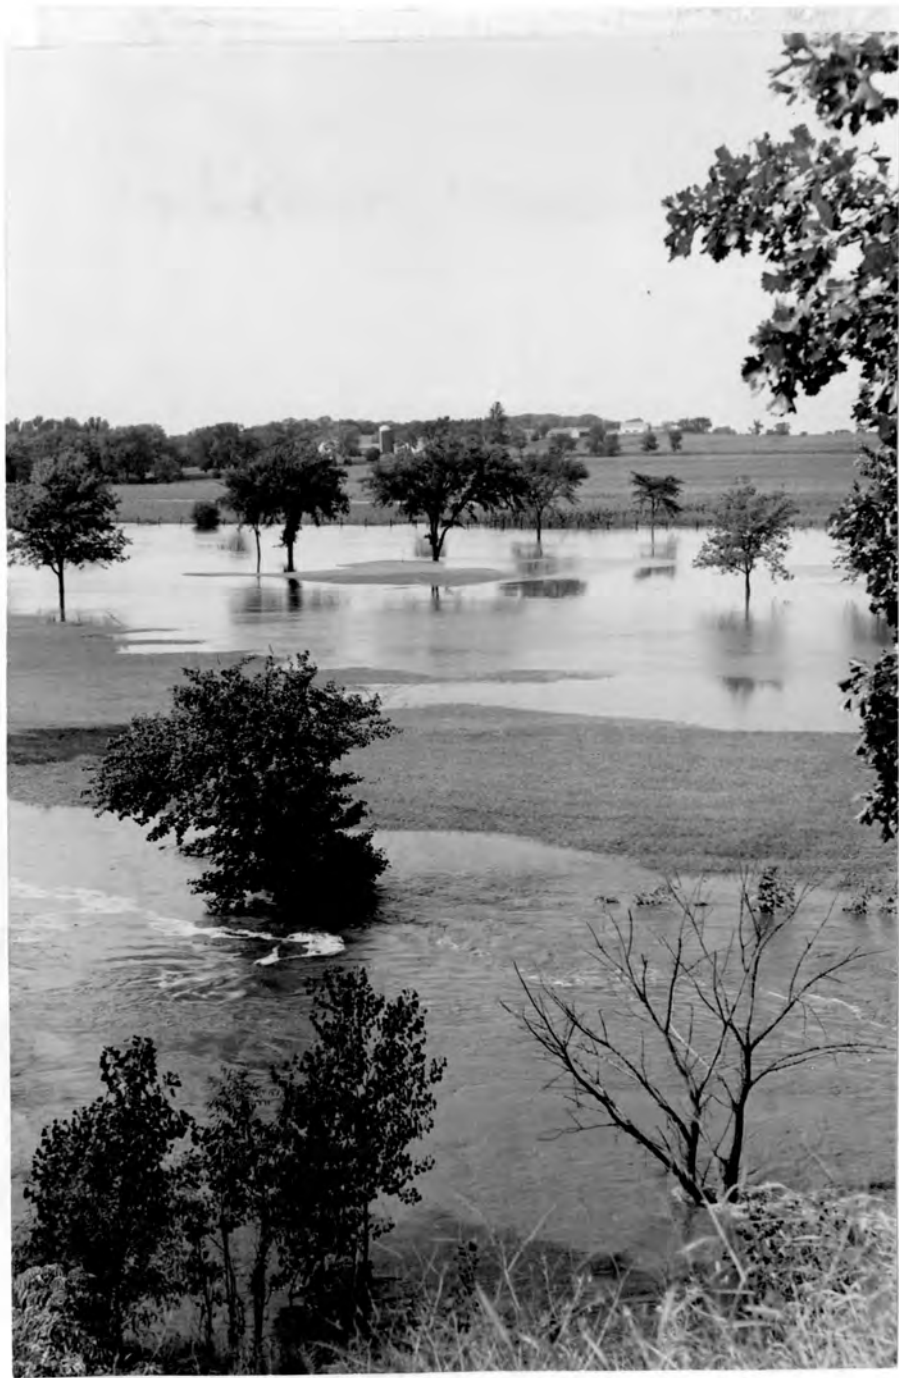
Figure 7. August, 1954 -- flooding of the University Golf Course
